RE: Miller et al. v City of Philadelphia et al.

As requested, JS Held investigated a Police pursuit that occurred shortly before 7:30pm on May 7th, 2019, in the neighborhood of Bridesburg, in Philadelphia, Pennsylvania. According to the *Internal Investigation Memorandum*, Mr. Ryan Miller, who was operating a Yamaha Scooter was being "pursued by police at the time of the incident." ¹ Officer Joseph Wolk, who was operating a Philadelphia Police patrol vehicle, can be seen in surveillance video, following Mr. Miller through the neighborhood prior to the crash. At the end of this pursuit, Mr. Miller died as a result of a collision with a tractor trailer at the intersection of Tacony Street and Fraley Street. *Figure 1* depicts an aerial image from Google EarthTM dated June 5, 2022, that depicts the general area where Mr. Miller was operating his motorcycle during the pursuit by Officer Wolk. The series of streets through which the pursuit was captured on video is depicted with an orange rectangle, and the specific intersection where the collision with the tractor trailer occurred is denoted with a red circle. The speed limit in the neighborhood is 25mph. At the time of the accident t

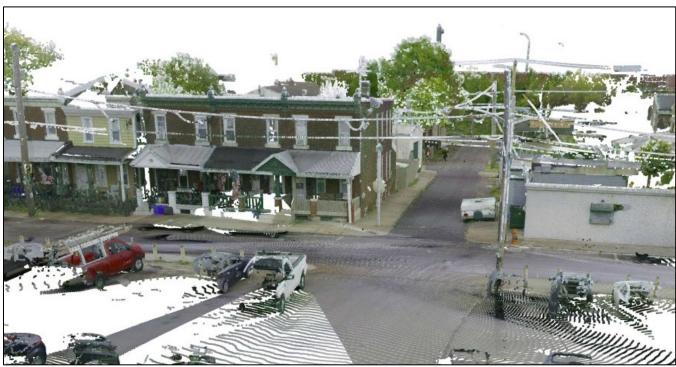
Figure 4 – Perspective view of the scan data at the intersection of Scattergood St. and Eadom St.

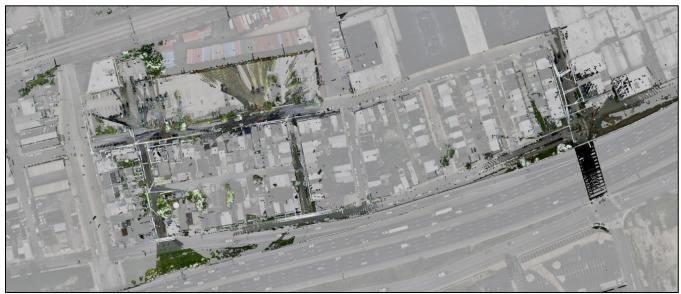
Figure 5 – Top down view showing locations of the scans performed during JS Held's scene inspection.

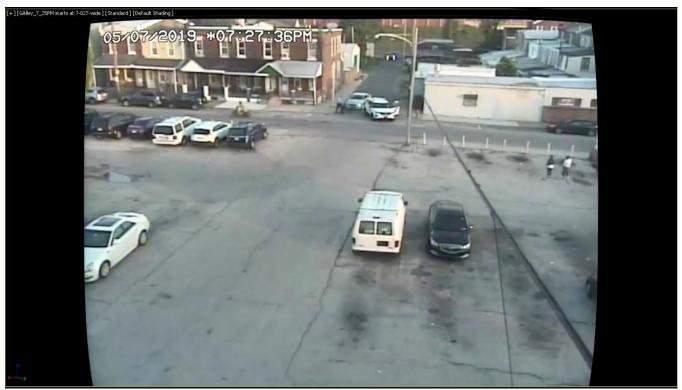
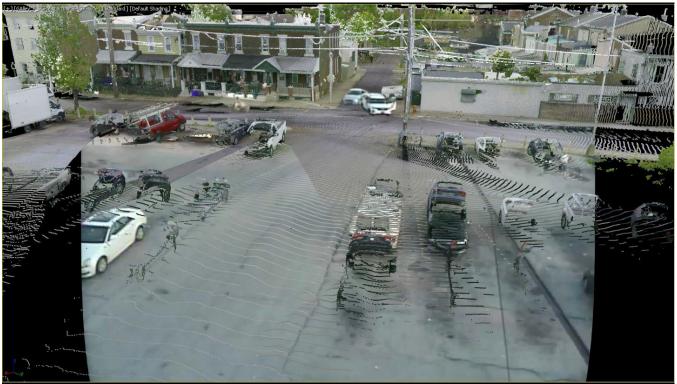
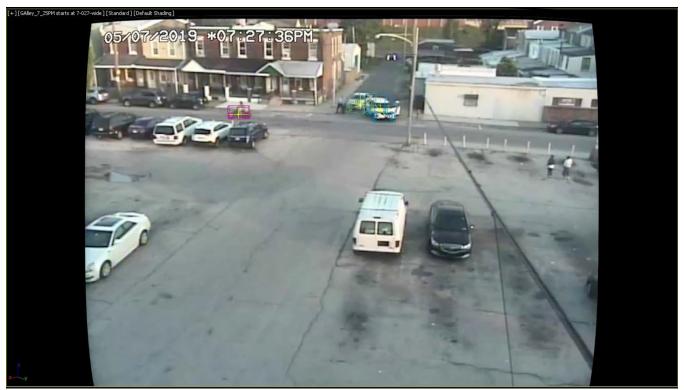
Figure 18 – Camera-matching process

Figures 18 to Figures 20 depict the camera matching and video tracking process for one of the security footage cameras. In this example the camera is located on a building with a view of the intersection of Scattergood Street and Eadom Street. The video depicts all three vehicles at the intersection, with Officer Wolk stopping and exiting his vehicle, prior to returning to his vehicle after the motorcyclist had turned east on Eadom Street. The additional vehicle, operated by Mr. Bove, can also be seen in the video at the intersection, stopped adjacent to Officer Wolk.

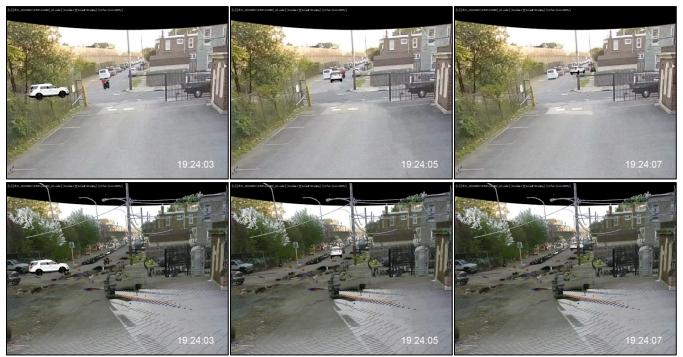
Figure 24 - Camera matched view of Camera 01, showing the tracking of Officer Wolk's Patrol vehicle and Mr. Miller's motorcycle.

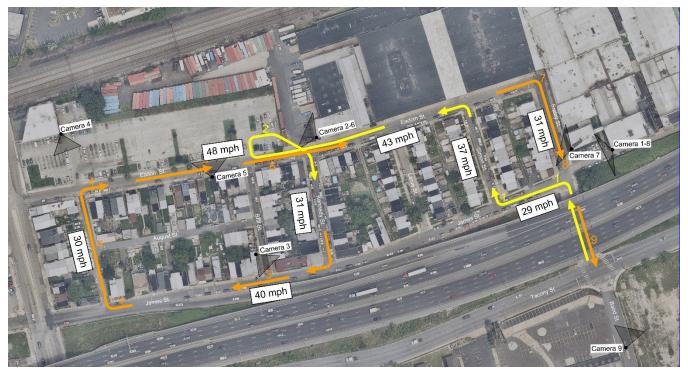
Based on the full sequence of the pursuit through the neighborhood, from the initial entrance and leading up to impact, an analysis of the speeds, accelerations, decelerations, and swerving that Officer Wolk achieved was performed. One analysis included determining the maximum speed that Mr. Wolk achieved on each street in the 25 mph speed limit neighborhood. *Figure 29* depicts the analysis, showing the speeds along the respective streets that this speed was achieved. From the analysis, it was determined that Officer Wolk exceeded the speed limit along every straight segment, and reached a speed approximately twice the speed limit when traveling on Eadom St.

Figure 29 – Analysis showing Officer Wolk's top speeds along straight-aways
